COASTAL RESTORATION SERIES

Freshwater Coastal Prairie Wetland Restoration— Case Study: Sheldon Lake State Park

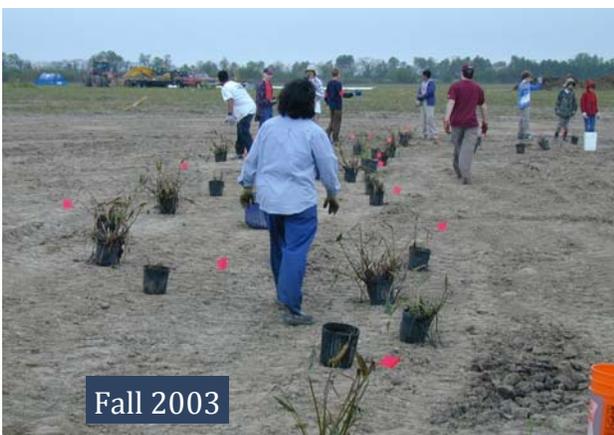
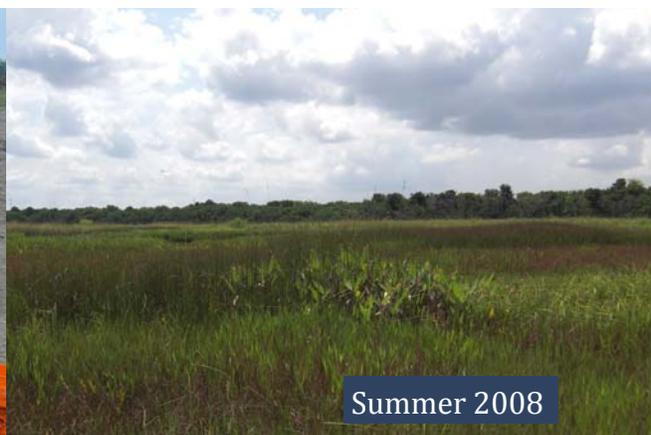
Fall 2003

Summer 2008

Wetland Restoration Team working with Eagle Scout Troop 505 to restore coastal prairie wetlands in Phase I, which is completely vegetated after 5 years.
