# **GROUND-TRUTH WETLAND MITIGATION ASSESSMENT**

**CLEAN WATER ACT SECTION 404**

**HOUSTON 8-COUNTY METRO REGION**

**JUNE 2017**

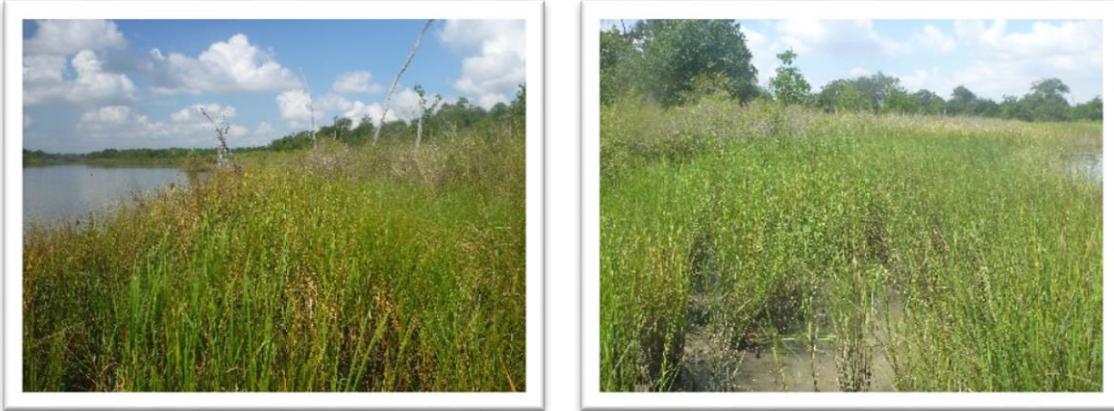
Typical view of the creation portion of the mitigation site.

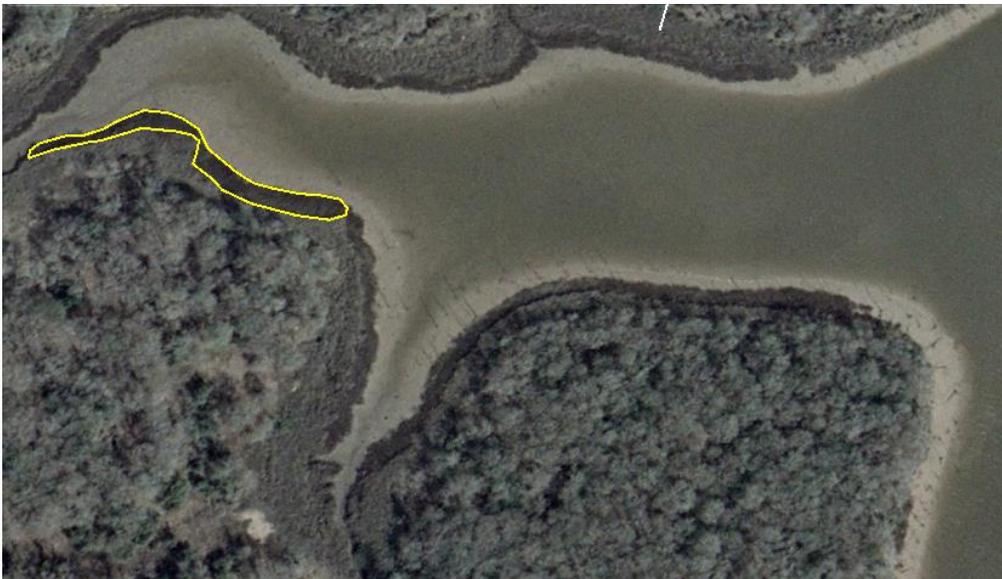
**AREA 1 IN TAYLOR LAKE BAYOU.** The outlined area is about 0.3 acres. It is a fringing area that does not appear in earlier photographs. This fringing area appears to be most prominent in Area 1

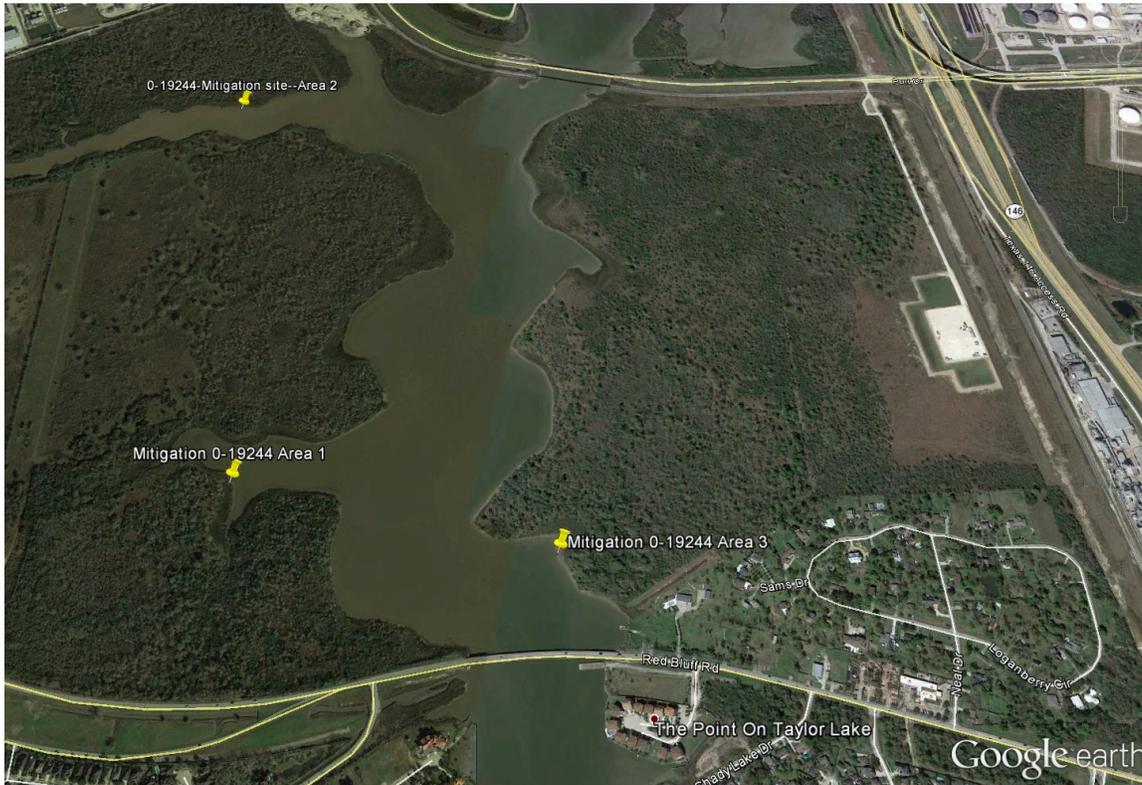
The three mitigation areas to be planted as mitigation. All three sites were visited. Site 2 was documented. The erosional scarp mentioned in the permit was present on all three sites. As with Armand Bayou, subsidence in the 1960's and 70's drowned existing wetlands. The stabilization of subsidence with the establishment of the Harris-Galveston Subsidence district makes it possible to reestablish wetlands such as these.

All indications are that the planting took place as required. The wetlands are still present and functioning well with a mature and healthy stand of *Spartina alterniflora*.

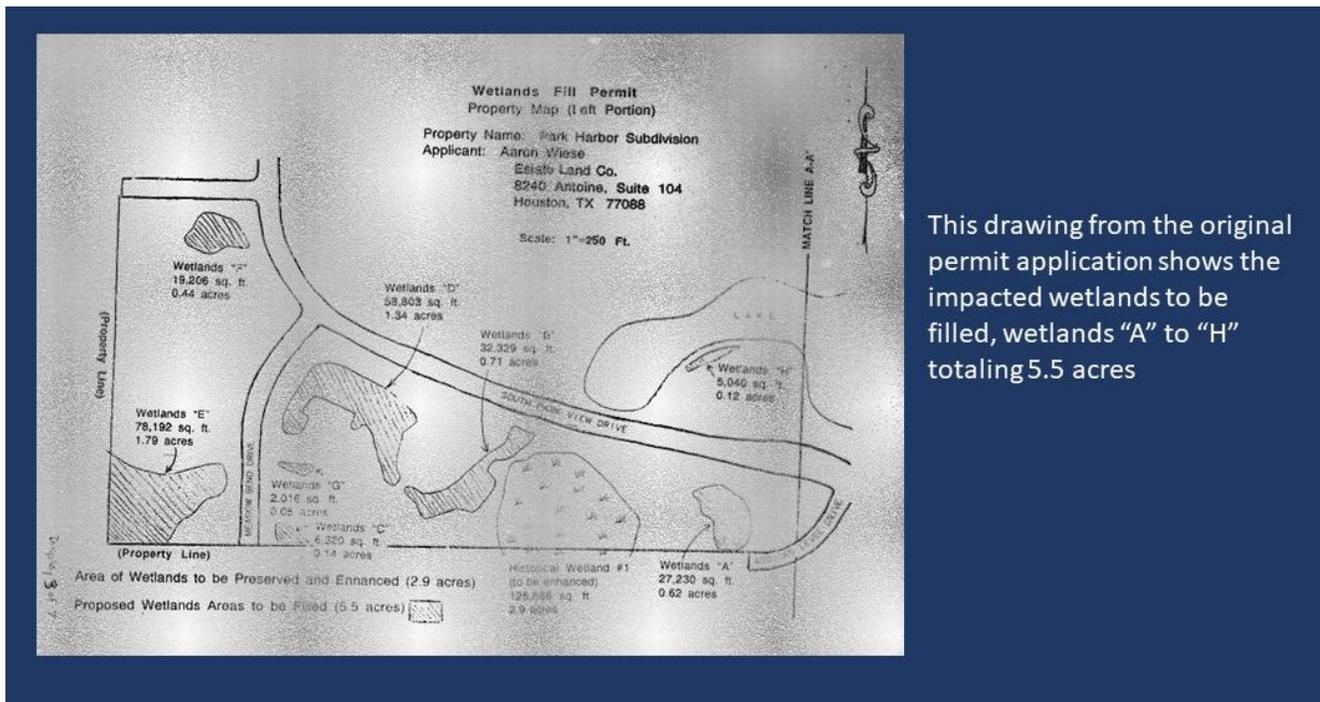
This drawing from the original permit application shows the impacted wetlands to be filled, wetlands "A" to "H" totaling 5.5 acres

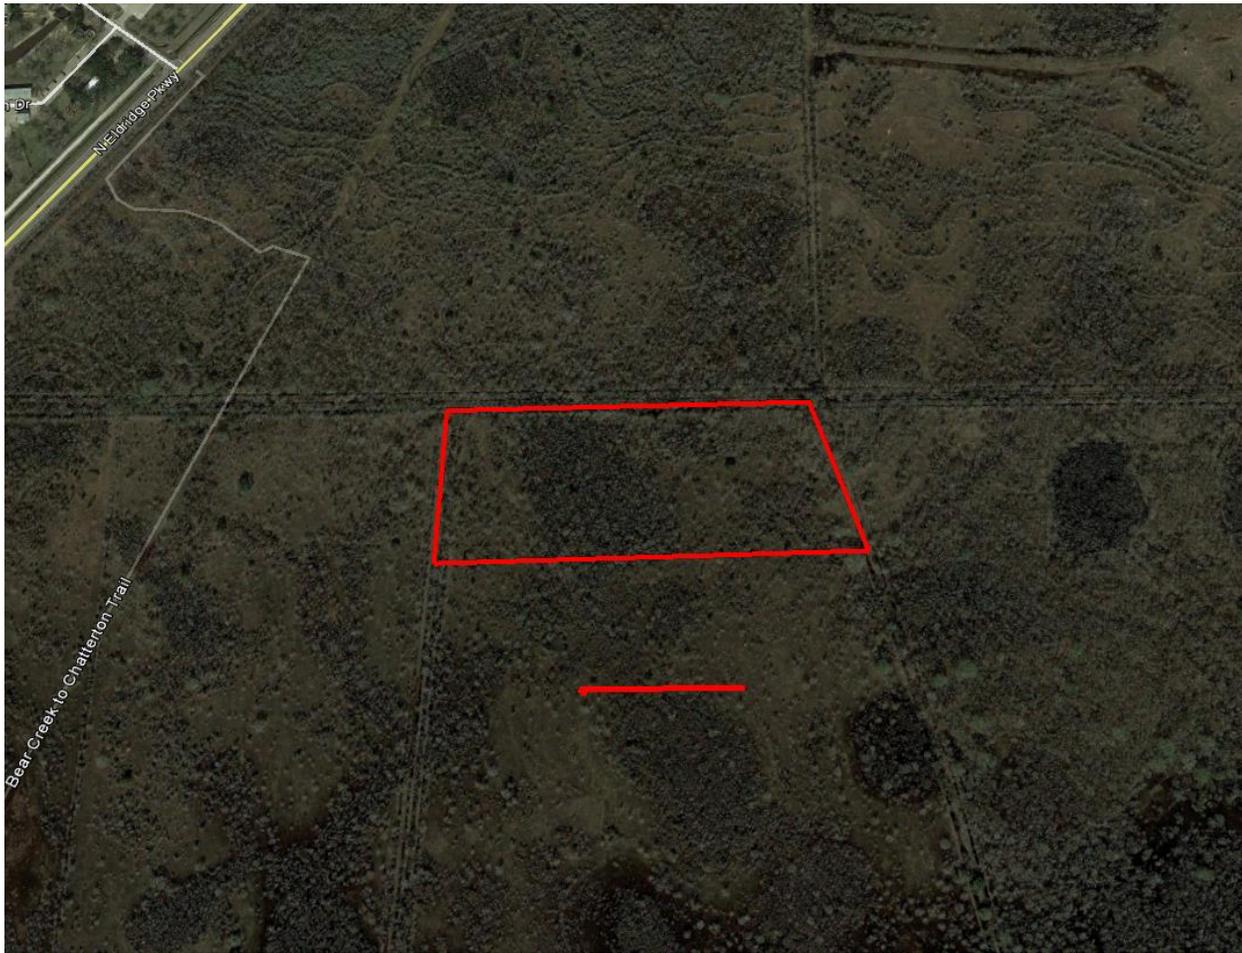
**Off-Site mitigation.** Air photo interpretation of Google Earth imagery from 1995 (1/1995; 9/2002; 2/04; 5/05; 1/06) does not reveal any activities consistent with the kind of earth moving that would be required on nearly half of this 16-acre block (see below) for the creation of the stated amount of wetlands. Furthermore, there is no significant change in in the tonal pattern of the 3-acre wetland that was to be restored in this block, a tonal pattern consistent with Chinese Tallow since 1989. The last entry in the permit documentation stated that the permit was pending the permission to complete the mitigation. The permission was perhaps received but there is no evidence in the paper trail nor on the ground that any of the mitigation activities were ever completed in accordance with the permit. The site manager for the reservoir was contacted and he verified that there is no record that this portion of the proposed mitigation was ever completed (phone conversation, October 2016).

16-acre mitigation site in the Addicks Reservoir. 1/23/17 Google Earth aerial photo. 3-acre restoration wetland is dark area just left of center. Scale bar is 500ft.

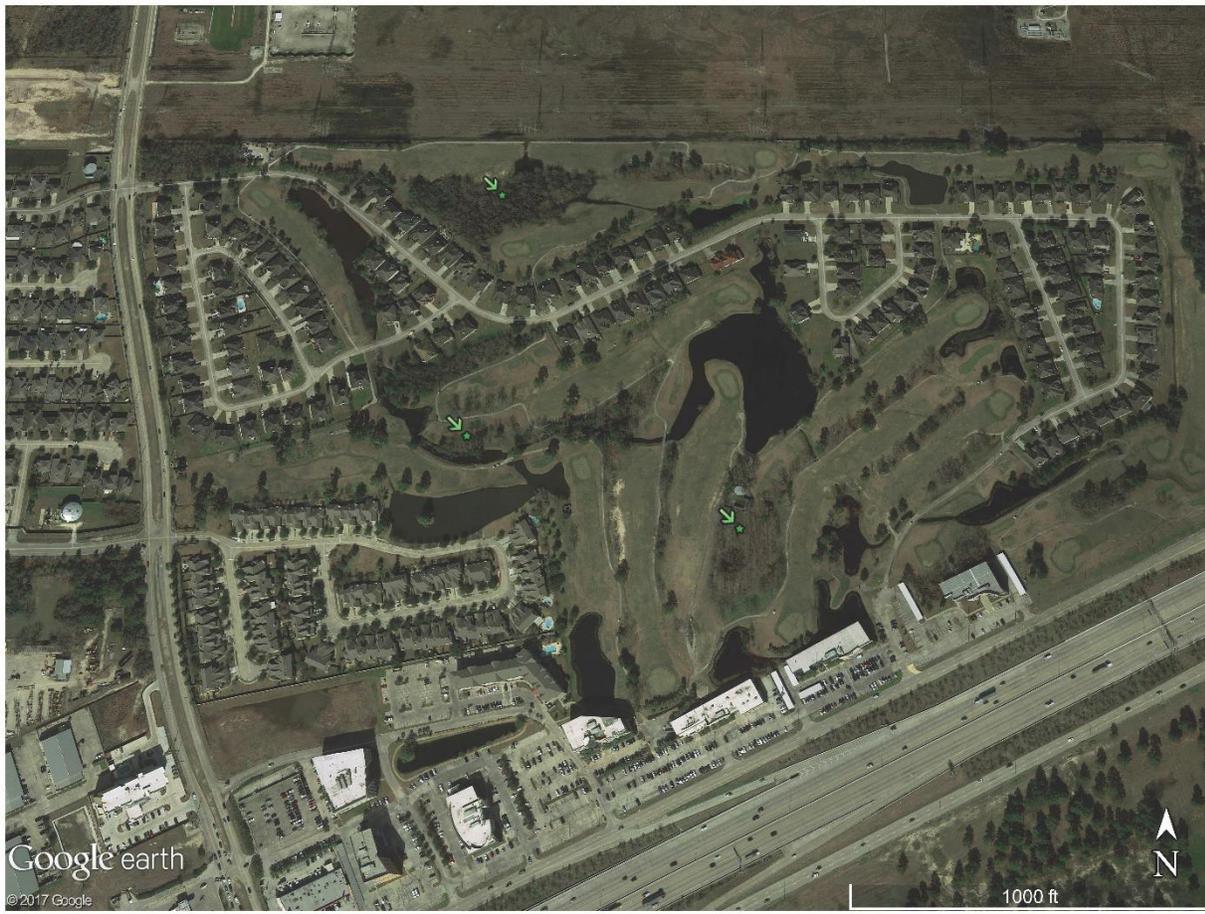
**Avoidance:** Recent aerial photography from Google Earth (GE) (2017) confirms the presence of the remnants of historical wetlands in the golf course, more or less consistent with the 6.4-acre requirement. The largest of these wetlands appear to be dominated by invasive Chinese Tallow trees. No enhancement was required in the permit. Wetlands preserved in an isolated condition within a highly-manicured golf course have a limited amount of ecological services that can be provided. Dossier analysis by R. Davanon in 2015 (on file with the Texas Coastal Watershed Program) revealed that some "avoided" wetlands were later filled.

Impact Site. Green arrows point to some of the “preservation wetlands” required by the permit.

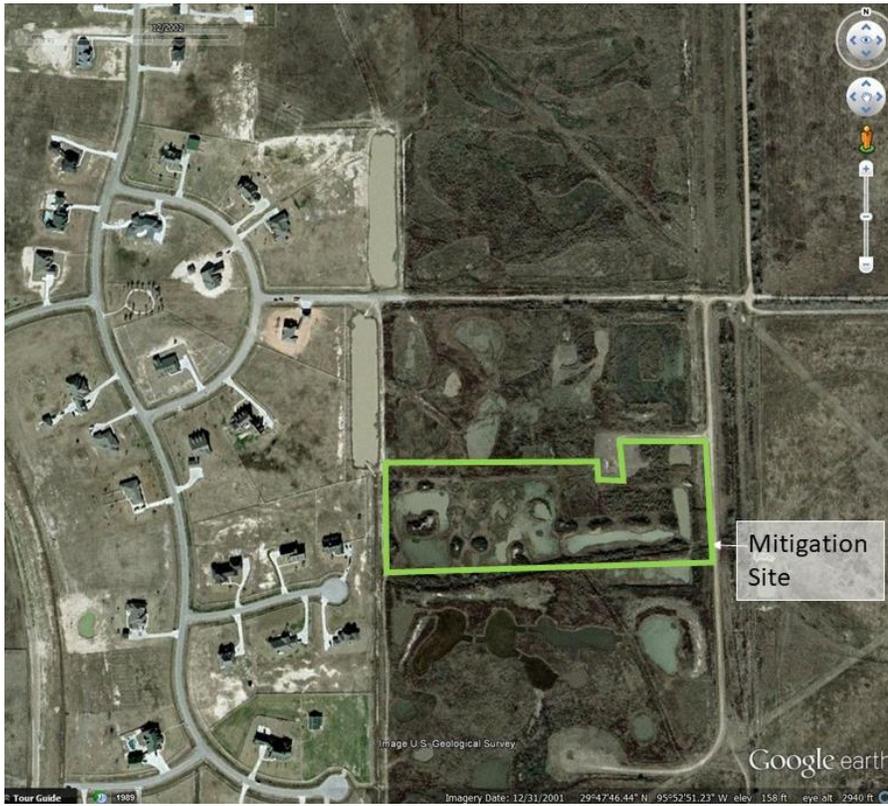
**Off-Site Mitigation.** For permit SWG-1995-01666, the site owner of the mitigation site was contacted on multiple occasions but did not return calls. Permission to access and assess was therefore not obtained. Based on the aerial photography and the assessment completed during a previous project phase, it is obvious that wetlands were created on the mitigation site, between 1995 and 2002, based on available GE imagery. While we could not directly assess the quality of the wetland mitigation without on-the-ground inspection, we could make some observations based on the aerial photography. It would appear that the acreage requirement has been met, and that these created wetlands retain some wetland features and functionality. However, most of the excavated areas at the creation site show an open water aerial photo signature in nearly every photo available from Google Earth, including relatively drier times of the year (e.g., October). An open-water pond is not the same thing as a wetland. It is quite clear that most of the so-called wetlands at the mitigation site do not have mature stands of wetland vegetation.

Mitigation site (green outline), Google Earth, 1/2017. Note open water signature of the putative wetlands.

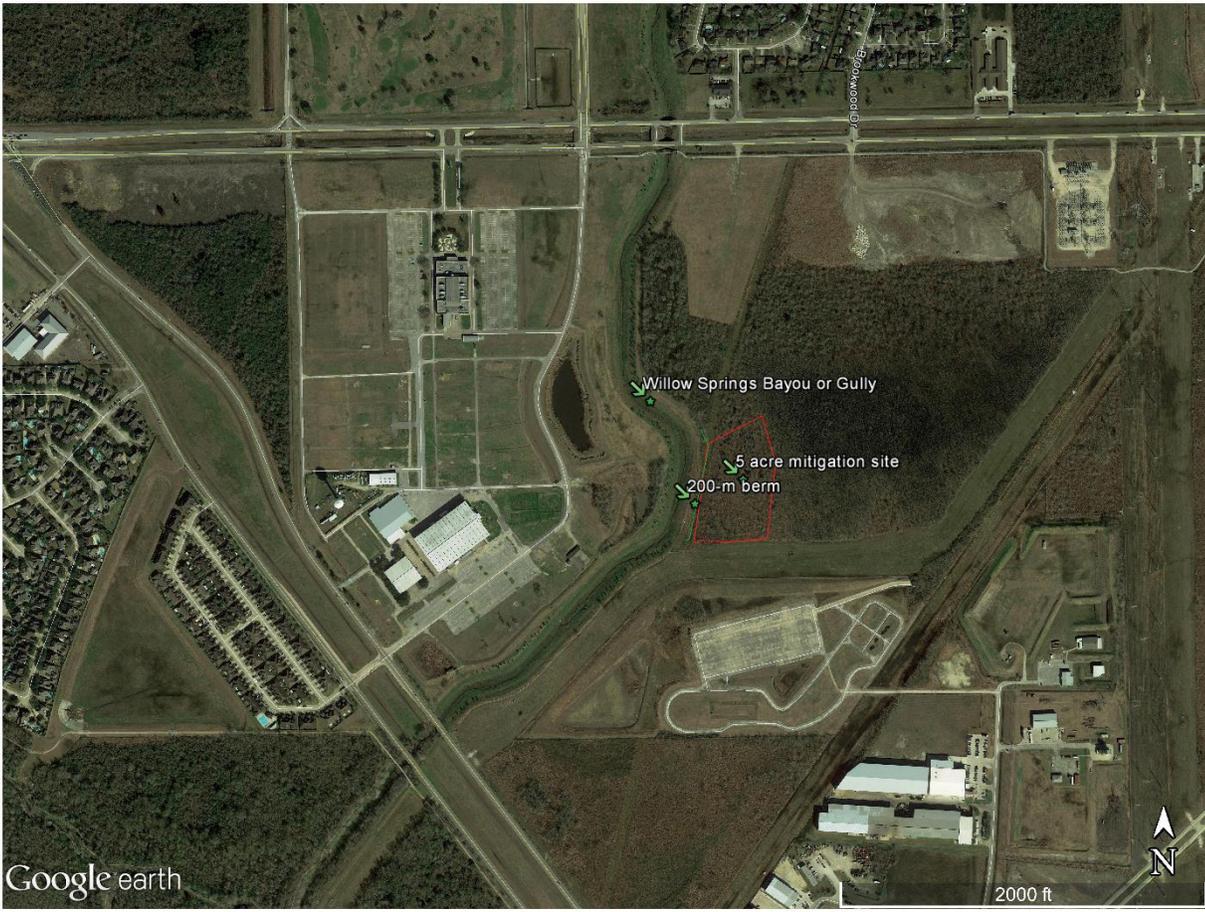
The consultant record detailing the mitigation work to be accomplished stated that 5.4 acres of wetlands would be established/enhanced by the construction of the berm on the east side of Willow Springs Bayou as described above. It is difficult to establish from the available aerial photography for this time period (1995 and 2002) whether or not the berm was completed. There does appear to be a v-notch weir in the location described in the mitigation proposal. But there does not appear to be any enhanced wetland hydrology, as evidenced by a darker tonal pattern on the aerial photography.

Google Earth aerial of the mitigation site, January 2017, with relevant features associated with the permit.

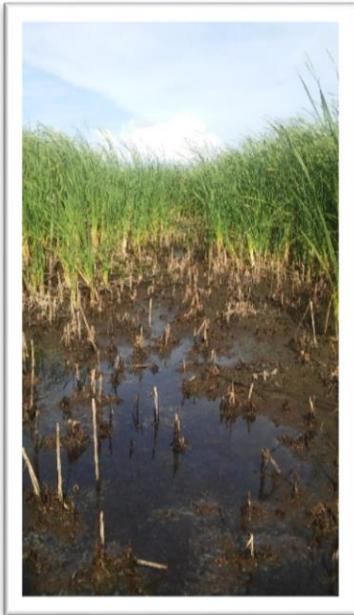
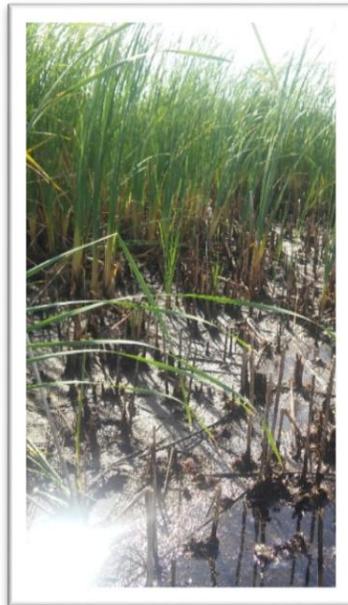
Typical view of the created portion of the wetland.

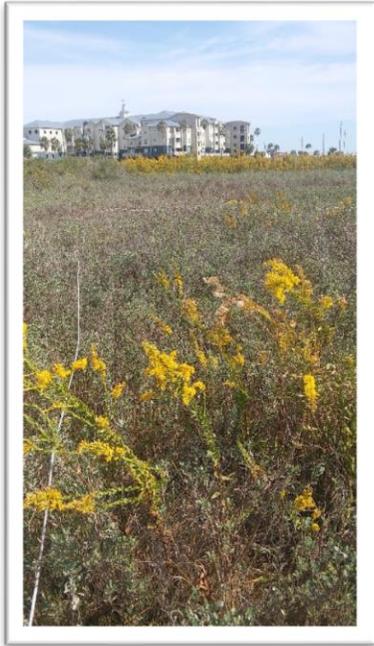
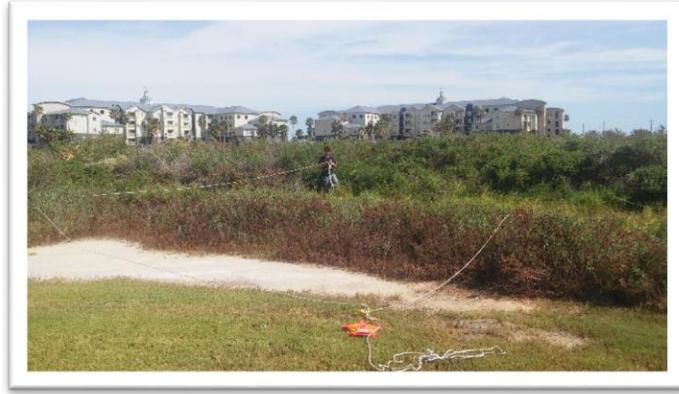
These photos reflect a typical view of the enhancement portion of the wetland.

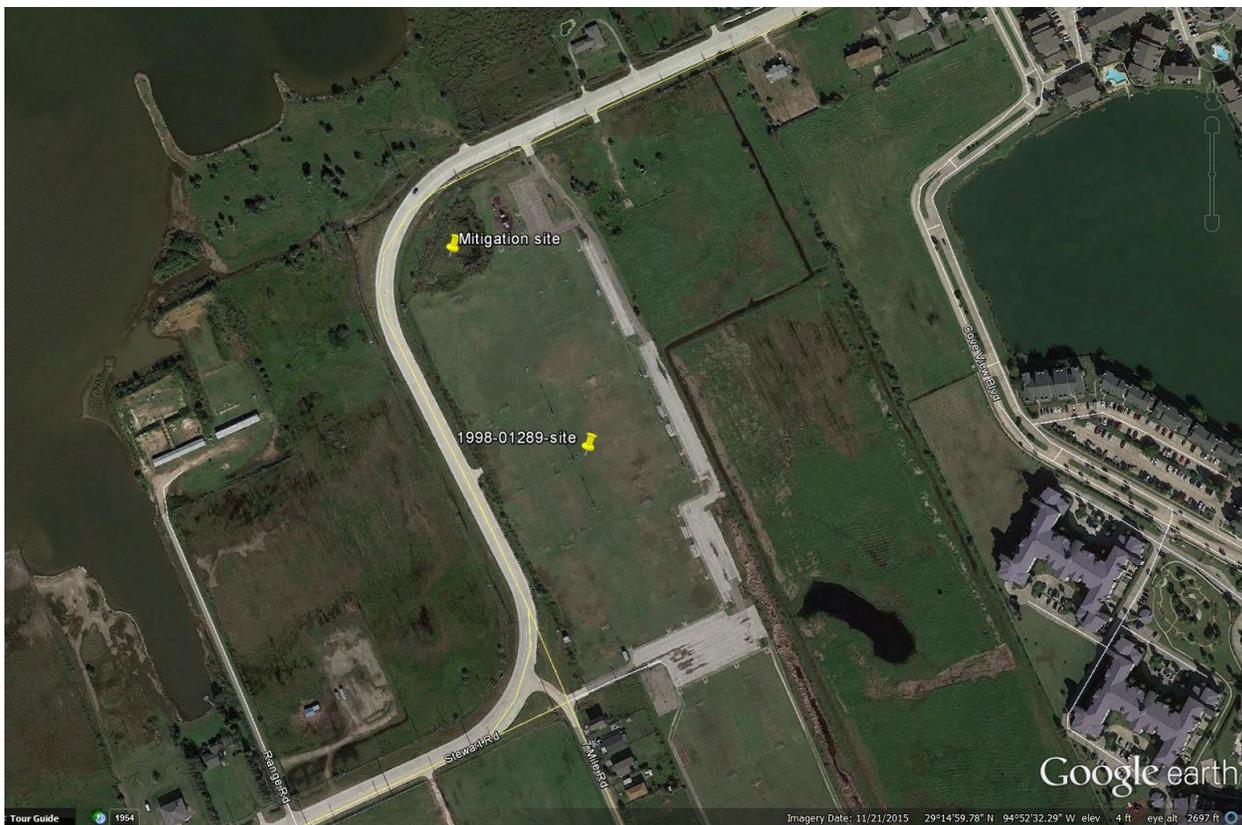
Aerial of the ballfield site. The main mitigation wetland is in the NW corner of the tract.

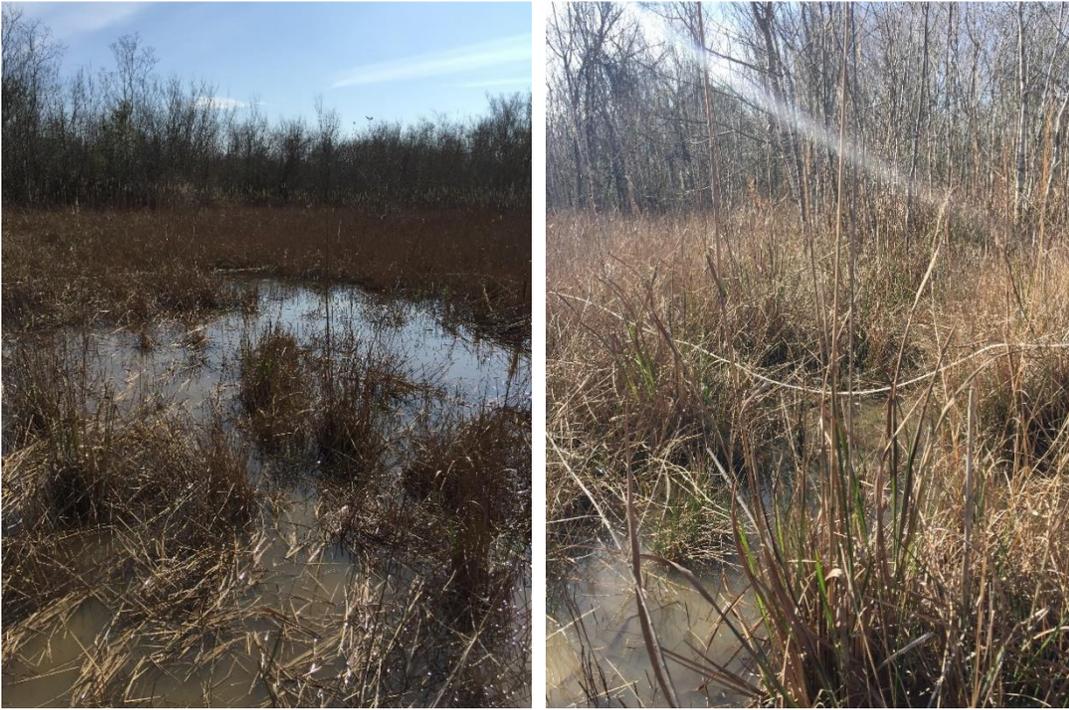
Typical landscape view of the created wetlands, January 2017.

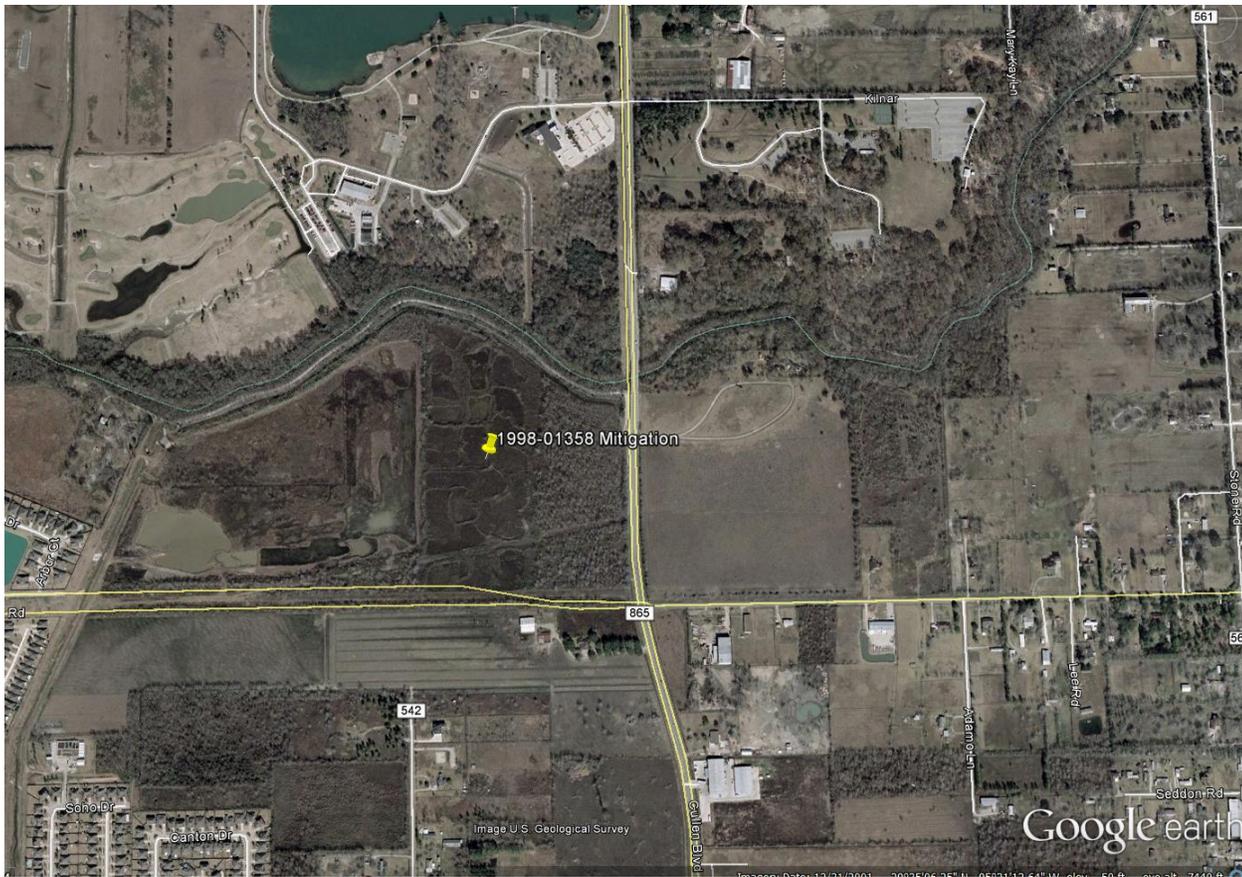
The mitigation site. Created wetlands are separated only by narrow berms. Natural wetlands do not occur in this pattern anywhere in the study area.

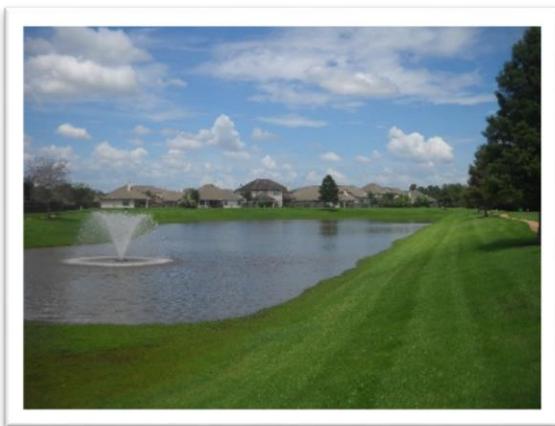
**INVESTIGATION RESULTS:** An on-site assessment was completed in August 2016. The mitigation site functions as a detention pond. There apparently were no requirements on the permittee beyond topsoil replacement. The topsoil may indeed have been placed on the floor of this basin, but the water depth is clearly too deep to support wetland vegetation.

Landscape view of the mitigation site; it is clearly heavily manicured detention area.

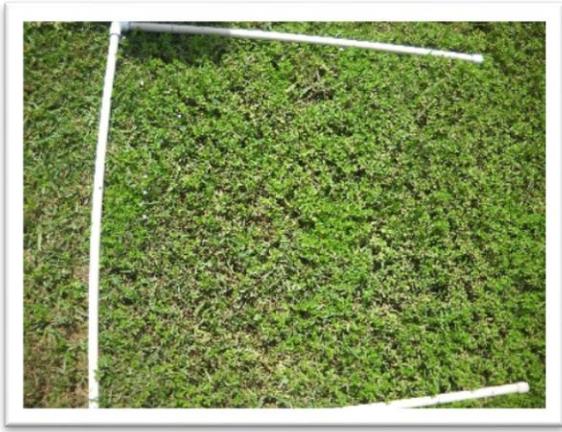
Wetland vegetation was present only on the edge of the pond, consisting mainly of invasive and non-native *Bacopa monnieri* (Water hyssop).

A typical view of a sample plot showing mowed down vegetation, primarily *Bacopa monneri*, along the pond edge.

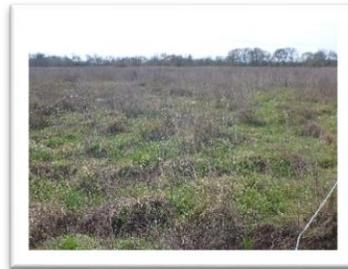
These pictures show typical landscape views of the mitigation site, January 2017.

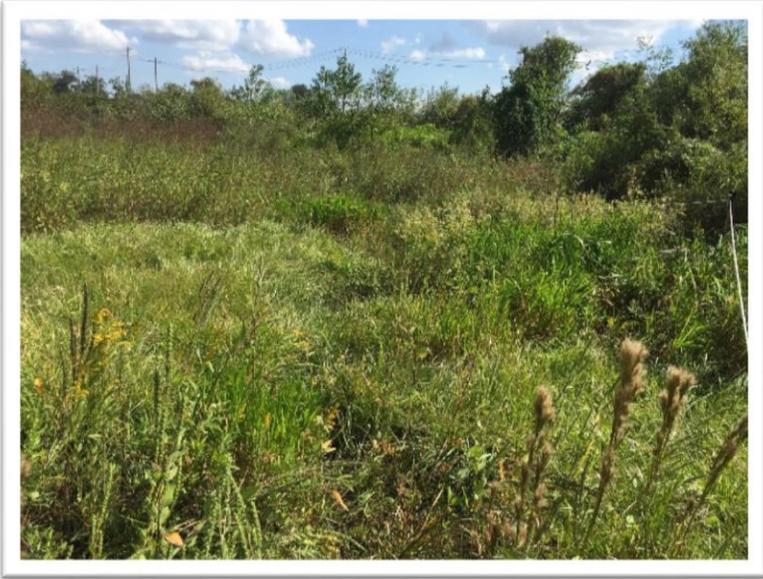
Conclusion: This site cannot really be considered a successful functioning wetland. The vast majority of the plants are upland. The 11% presence of *Panicum hemitomon* (Maindencane) is an outlier, but its presence is significant, suggesting the presence of at least some hydrology.

A typical landscape view of the creation portion of the mitigation site.

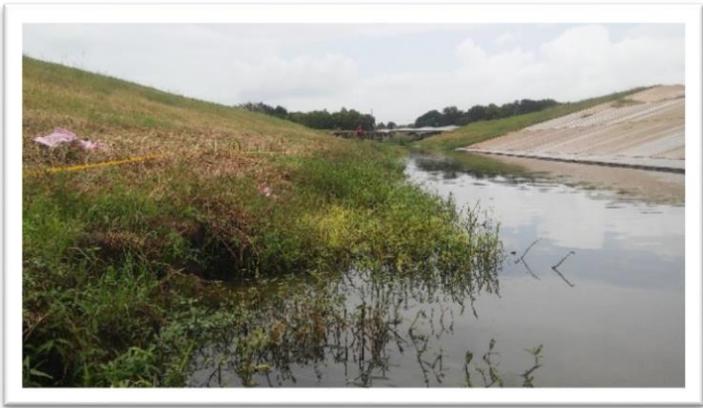
Ground view of mitigation site, October 2016

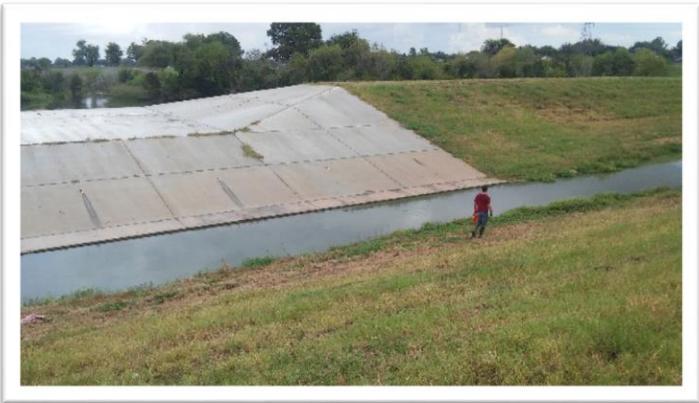
View of the site from the top of the adjacent slope, October 2016

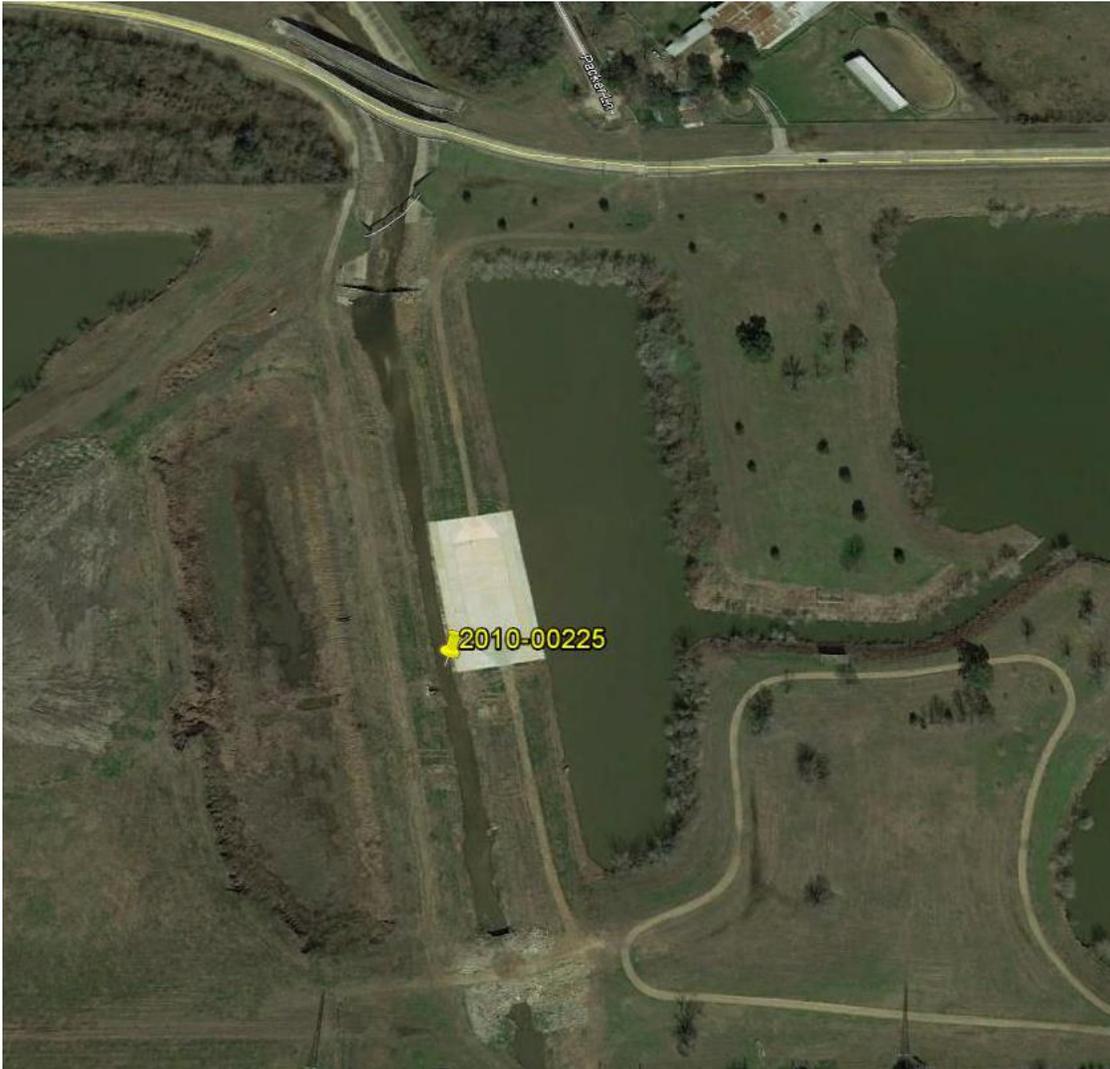
The mitigation site was completed per the proposed plan at the site. Approximately 61% of the vegetative cover was dominated by obligate to facultative wetland plants and 33% of the site is open water, demonstrating the hydrology for the site. Additionally, the soil samples show wetland features typical of fresh water systems. This wetland mitigation site is a fringing marsh area that creeps into the open channel and runs the length of the channelized area (800 ft). It is also bordered by steep slopes on either side and a concrete weir in the middle of one side.

Google Earth aerial view of the project/mitigation site, January 2017
